# **Report of Structural Inspection and Condition Assessment of Trimming Room - Areas 2 & 3 and Press Room - Area 12\* at the Former Bossert Manufacturing Facility**

Utica, New York

**EARTH TECH, INC.**

*Project No. 24708.01*

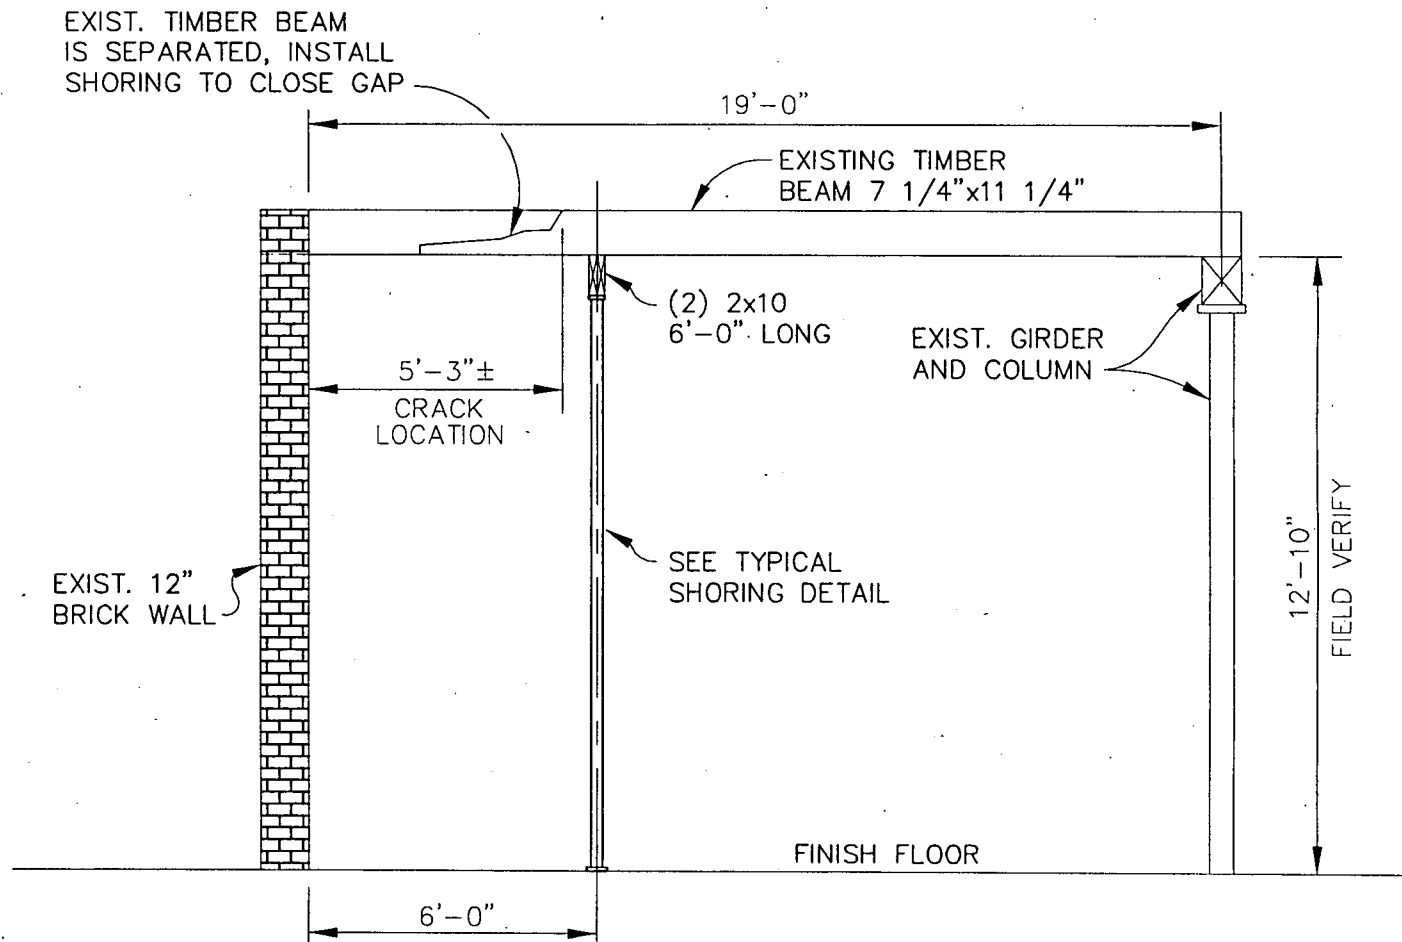
## AREA 3-BUILDING ELEVATION LOOKING NORTH

NOTE:  
SHORING MUST BE INSTALLED  
ON EAST SIDE OF VERTICAL  
CRACK

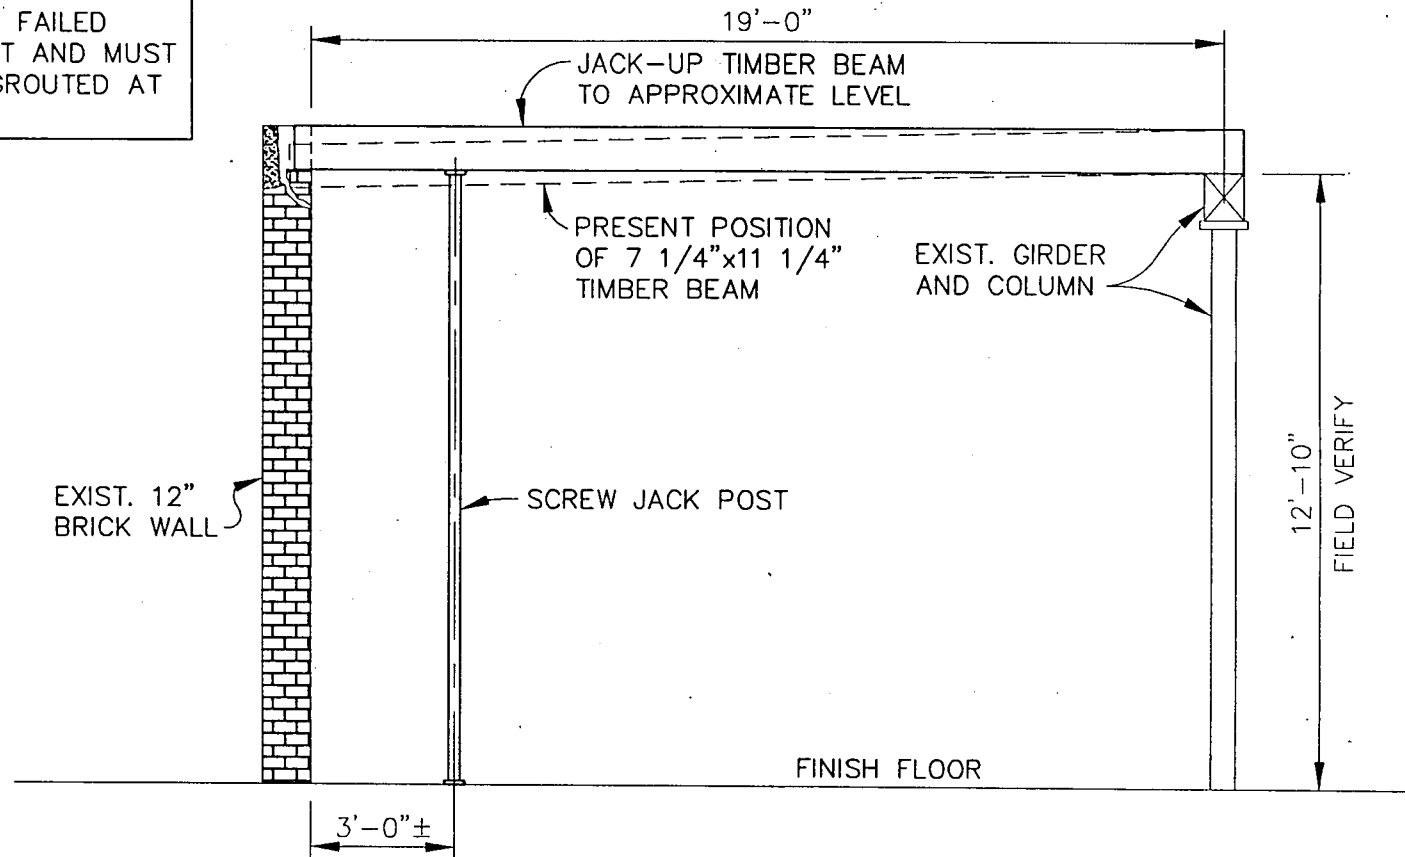
**AREA 3-BUILDING ELEVATION  
LOOKING NORTH**

TIMBER BEAM HAS FAILED  
AT BRICK SUPPORT AND MUST  
BE JACKED AND GROUTED AT  
BRICK WALL

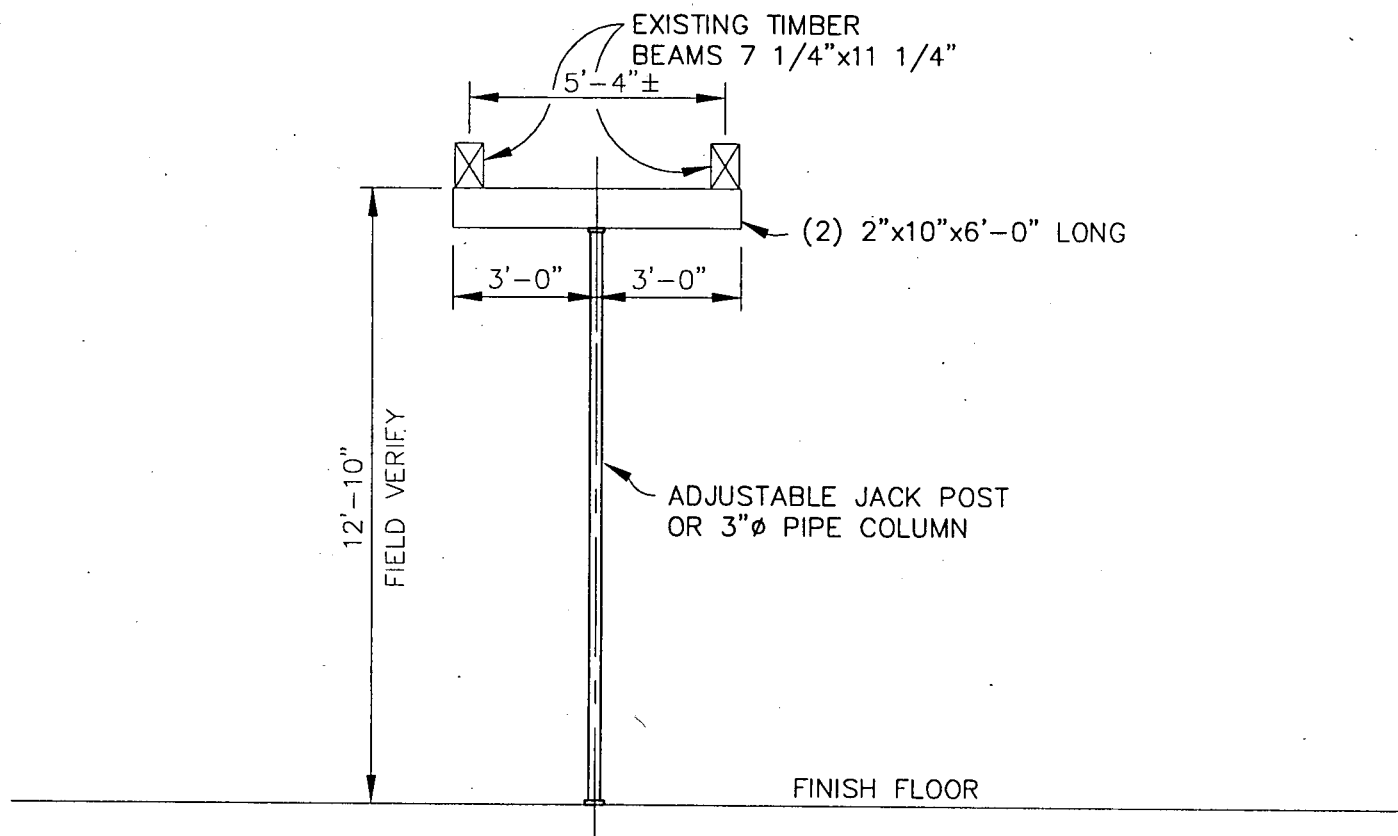
## AREA 3-TYPICAL SHORING DETAIL AT WOOD BEAMS

NOTE:  
SHORING MUST BE INSTALLED  
ON EAST SIDE OF VERTICAL  
CRACK

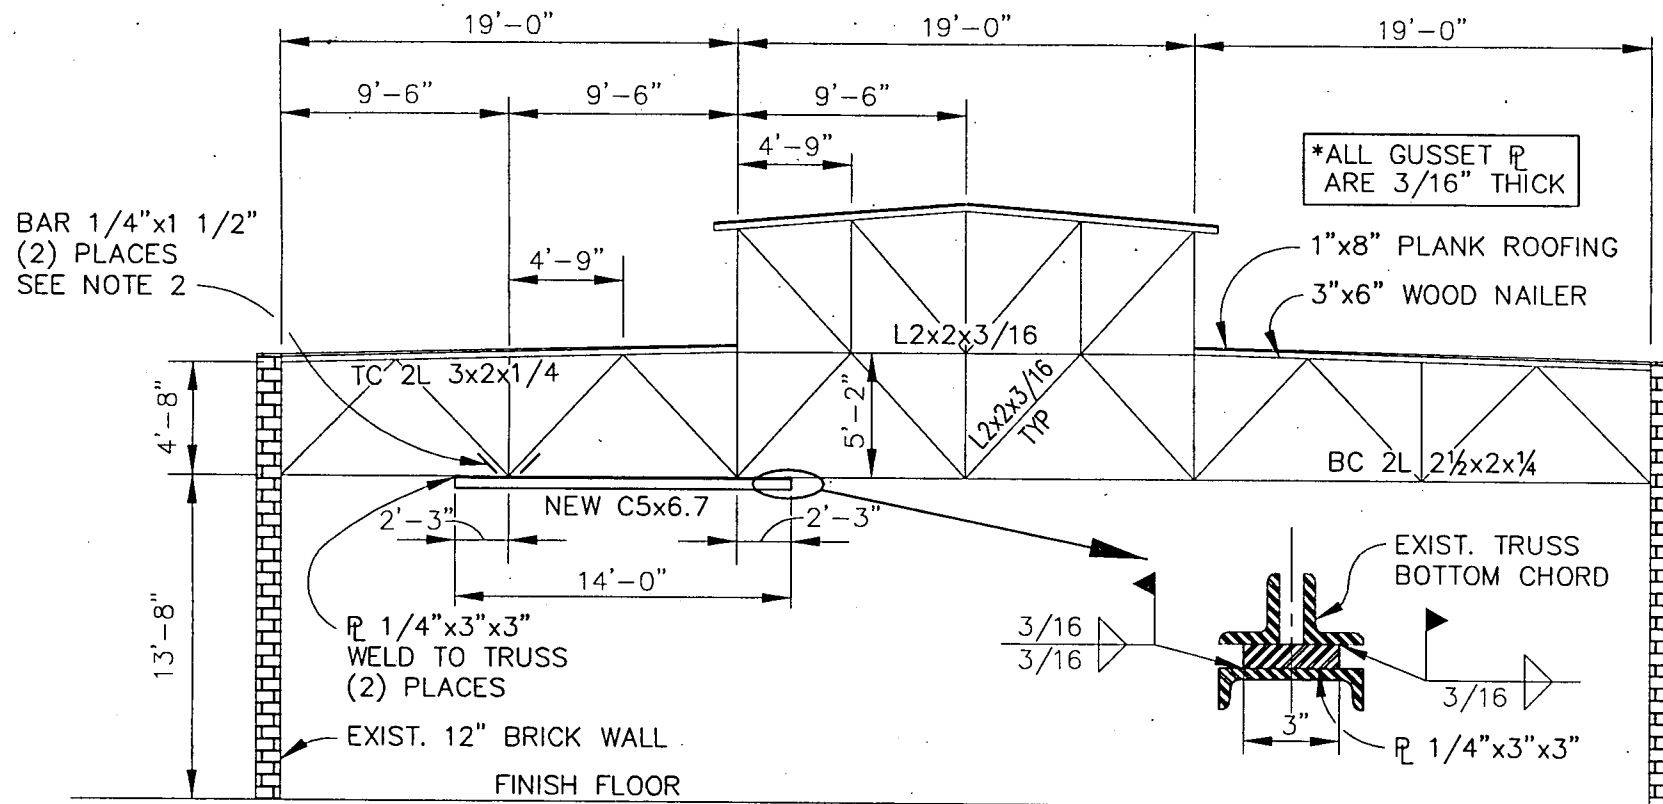
## AREA 2-BUILDING ELEVATION LOOKING SOUTH

The 12" brick bearing walls are in generally good condition and support the ends of the steel trusses. The ends of the trusses are fully embedded in the brick masonry with no evidence of loose brick surrounding the truss ends. The overall appearance of the trusses show that they are well constructed and have less than 10% material loss at any cross-section. There are exceptions. Two (2) trusses exist with a missing lower chord member, obviously due to intentional cutting and removal likely at a time when the plant was operational. Specifically, the lower chord double angle  $2L2\frac{1}{2} \times 2\frac{1}{4}$  was removed and a gusset was severely damaged as shown on sketch Detail 1 of the APPENDIX.

An analysis of the truss indicates that the missing member is needed to transfer the "tension force" to the remaining members between lower chord panel points. A calculated tension load of 36 kips in this member is due to combined dead and snow load. A replacement member is required to be field welded at the two (2) affected trusses.

1. CLEAN ALL SCALE FROM SURFACES PRIOR TO WELDING
2. PLACE 1/4"x1 1/2" BARS ON TRUSS ONLY
3. E70XX ELECTRODES
4. A36 STEEL

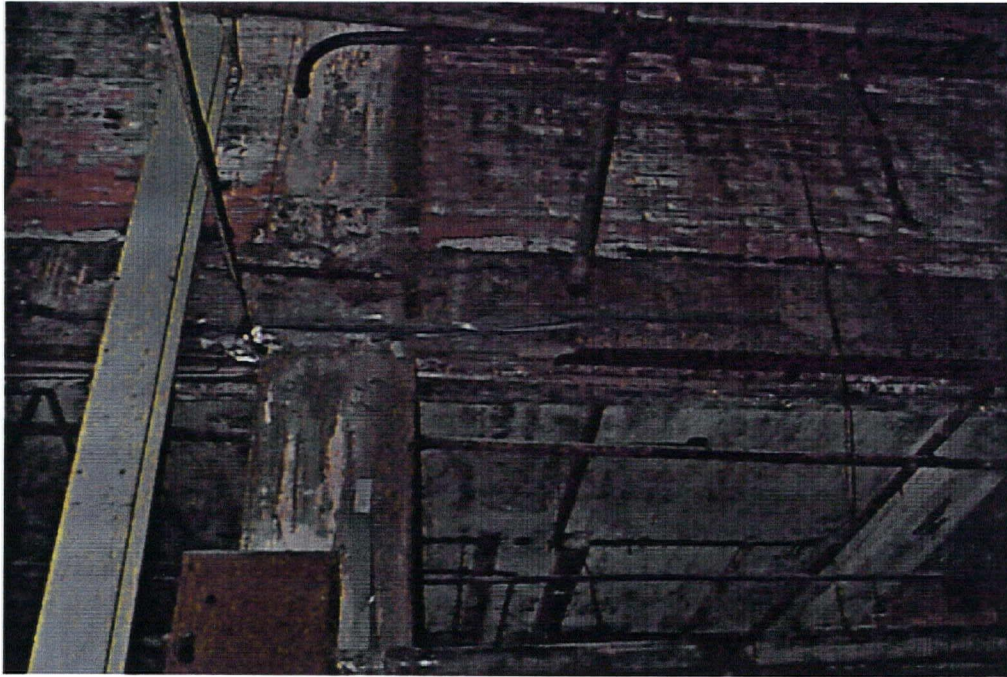
**IMAGE NO. 1**

IMAGE NO.	AREA NO.	DESCRIPTION
1	12	Concrete beam is cracked with exposed rebar. North side of building. No repairs are needed because the beam is considered safe.
2	12	Same as Image No. 1. No repair is required.
3	12	Wood beam has failed near brick wall. East side of building. Repairs should be made per Detail <u>2 &amp; 3</u> of this report.
4	12	Roof Collapse has caused instability of structural frame. See Detail <u>16</u> for repairs.
5	12	Roof failure has cause unstable support columns. Repair per Detail <u>16</u> .
6	12	Loss of beam lintel support at brick wall. Repair per Detail <u>18</u> .
7	12	Roof purlin failure and broken roof sheathing. Repair per Detail <u>13</u> .
8	12	Brick wall has missing or loose brick. Repair per Detail <u>12</u> .
9	12	Severe brick loss at areas of roof support columns. Repair per Detail <u>12</u> .
10	12	Broken wood beam. Repair per Detail <u>2 &amp; 3</u> .
11	10/11	Exterior walls of brick wall are in poor condition. There is to much window area to provide adequate structural support of roof. Demolish second floor walls and roof as described in Report.

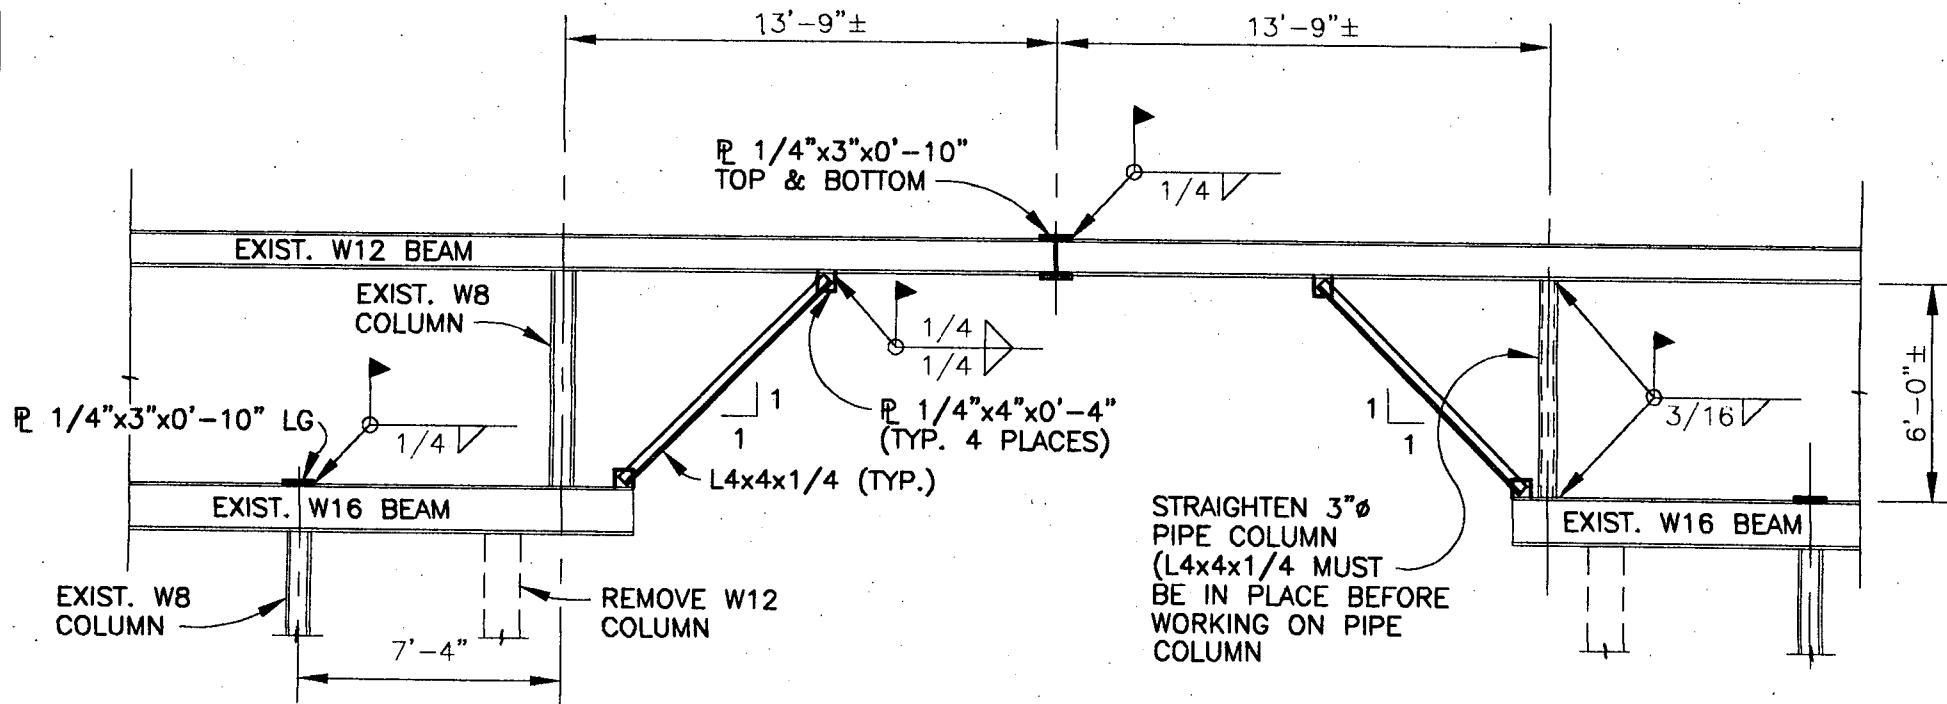
| 16 | a. Steel pipe column is not plumb.<br>b. Upper W12 Steel beams are not connected together.<br>c. Loose W12 column. | Straighten and weld structural angle as shown in Detail <u>16</u> .<br>Weld top and bottom plates to beam.<br>Weld top plate to top of beam. Add structural angle, then remove W12 column. |

NOTE: 1/4" TOP BEAM PLATE  
AND L4x4x1/4 KICKER MUST  
BE IN PLACE BEFORE REMOVING  
W12 COLUMNS

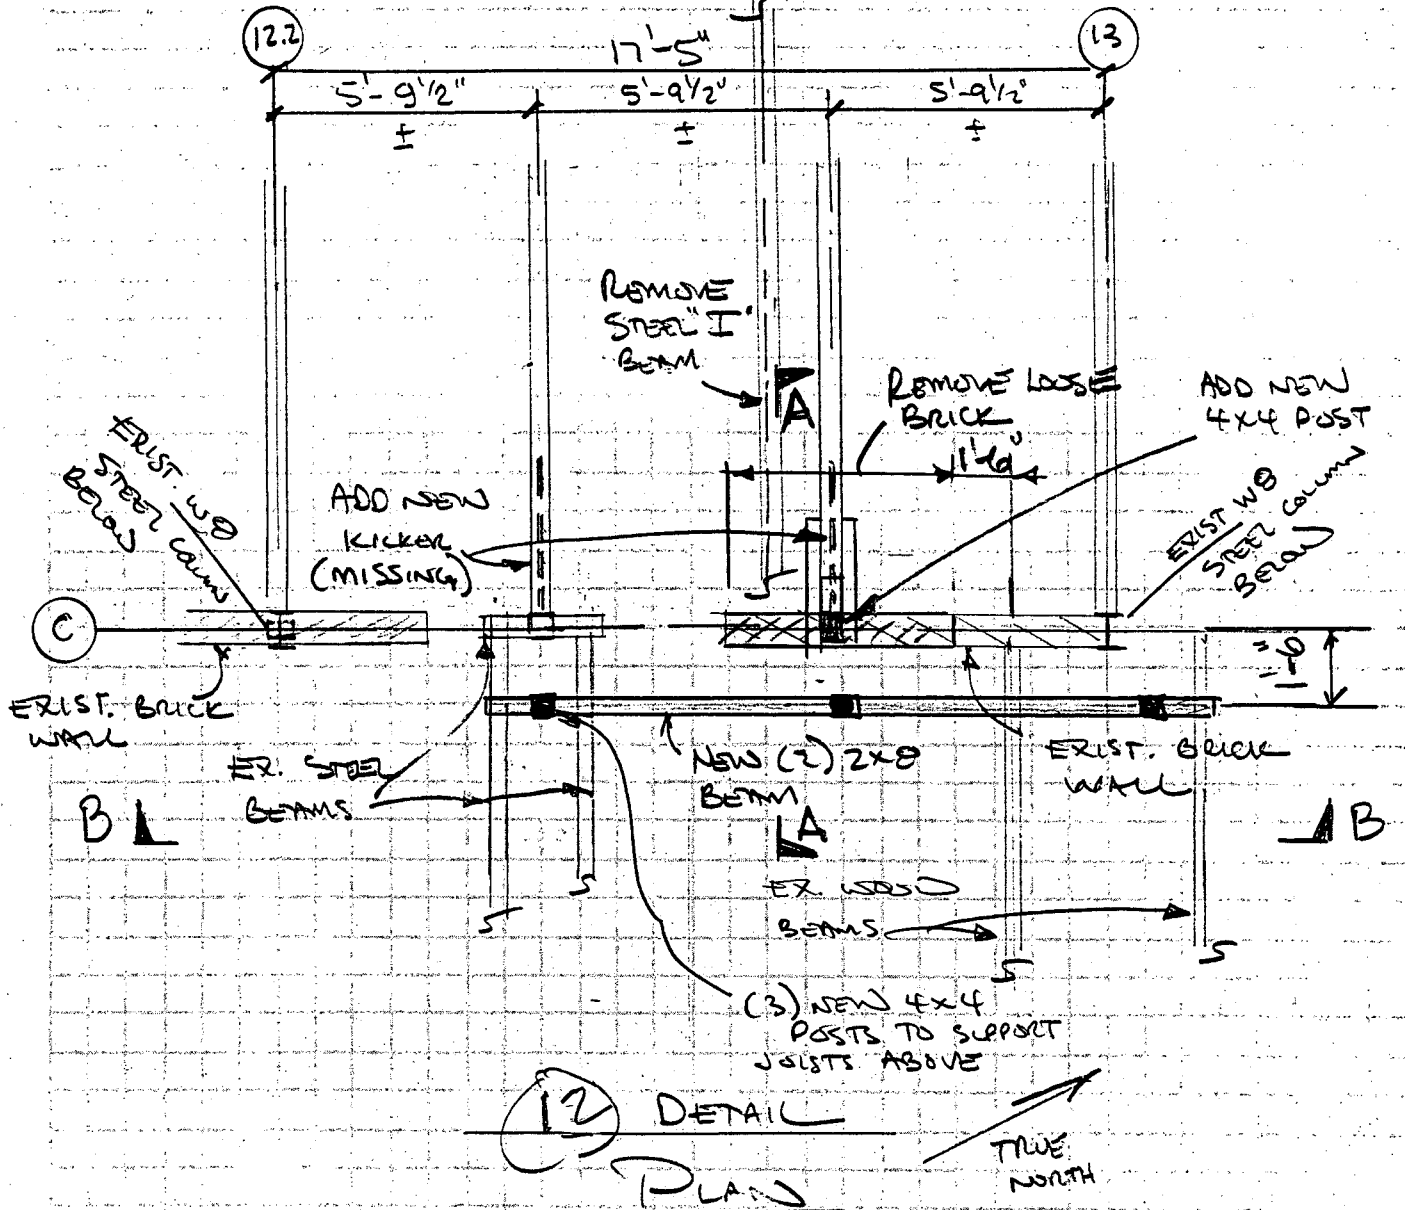
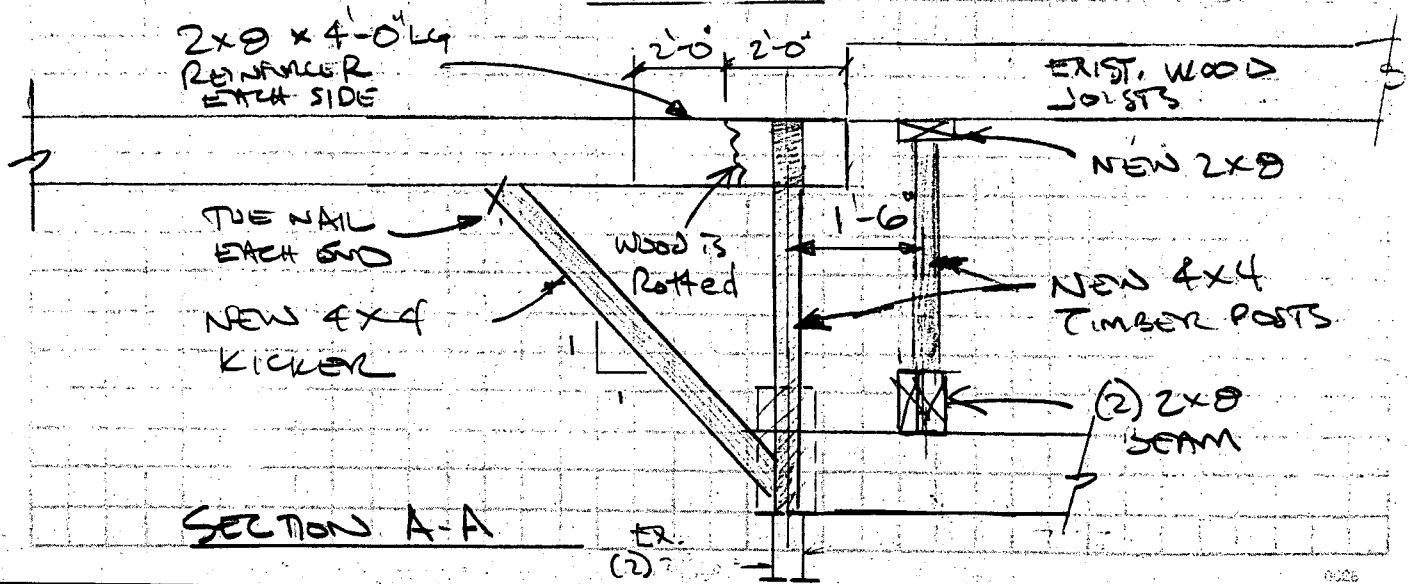
DETAIL 12

adjacent to the roof collapse should be roped off to protect workers near the unstable roof. Also, wood beams and brickwalls are unstable at locations shown in Detail 12.

12	a. Missing kicker and missing 4x4 post b. Loose and missing brick c. Broken joist bearing plate d. Rotted timber beam	Add posts and kickers per Detail <u>12</u> . Remove brick where shown on Detail <u>12</u> . Place wood beam to support existing wood joists per Detail <u>12</u> . Add 2x8 reinforcer on each side per Detail <u>12</u> .
13	(5) wood joists are broken	Nail 2x8 reinforcers on one side of each joist. See Detail <u>13</u> .

3. Wood beams which have been damaged should be reinforced where shown in the details of the APPENDIX.
4. Some wood braces or beams are missing as a result of partial roof collapse. These items are specially listed in the APPENDIX. Replacement members should be added as noted in Detail 15.
5. Steel frames are unstable as a result of the partial roof collapse described above. Frames should be braced to ensure stability. Repairs are shown in Detail 16.
6. Extreme caution is advised to keep heavy equipment from impact on any building column.
7. Remove loose roofing plank or deck that may cause hazard to workmen below.
8. Rope off or barricade the area of roof collapse where shown on the Floor Plan - APPENDIX.
9. Wood beams and brick walls are unstable at locations shown in Detail 12. Repair as shown. (See also sections 1 and 2.)

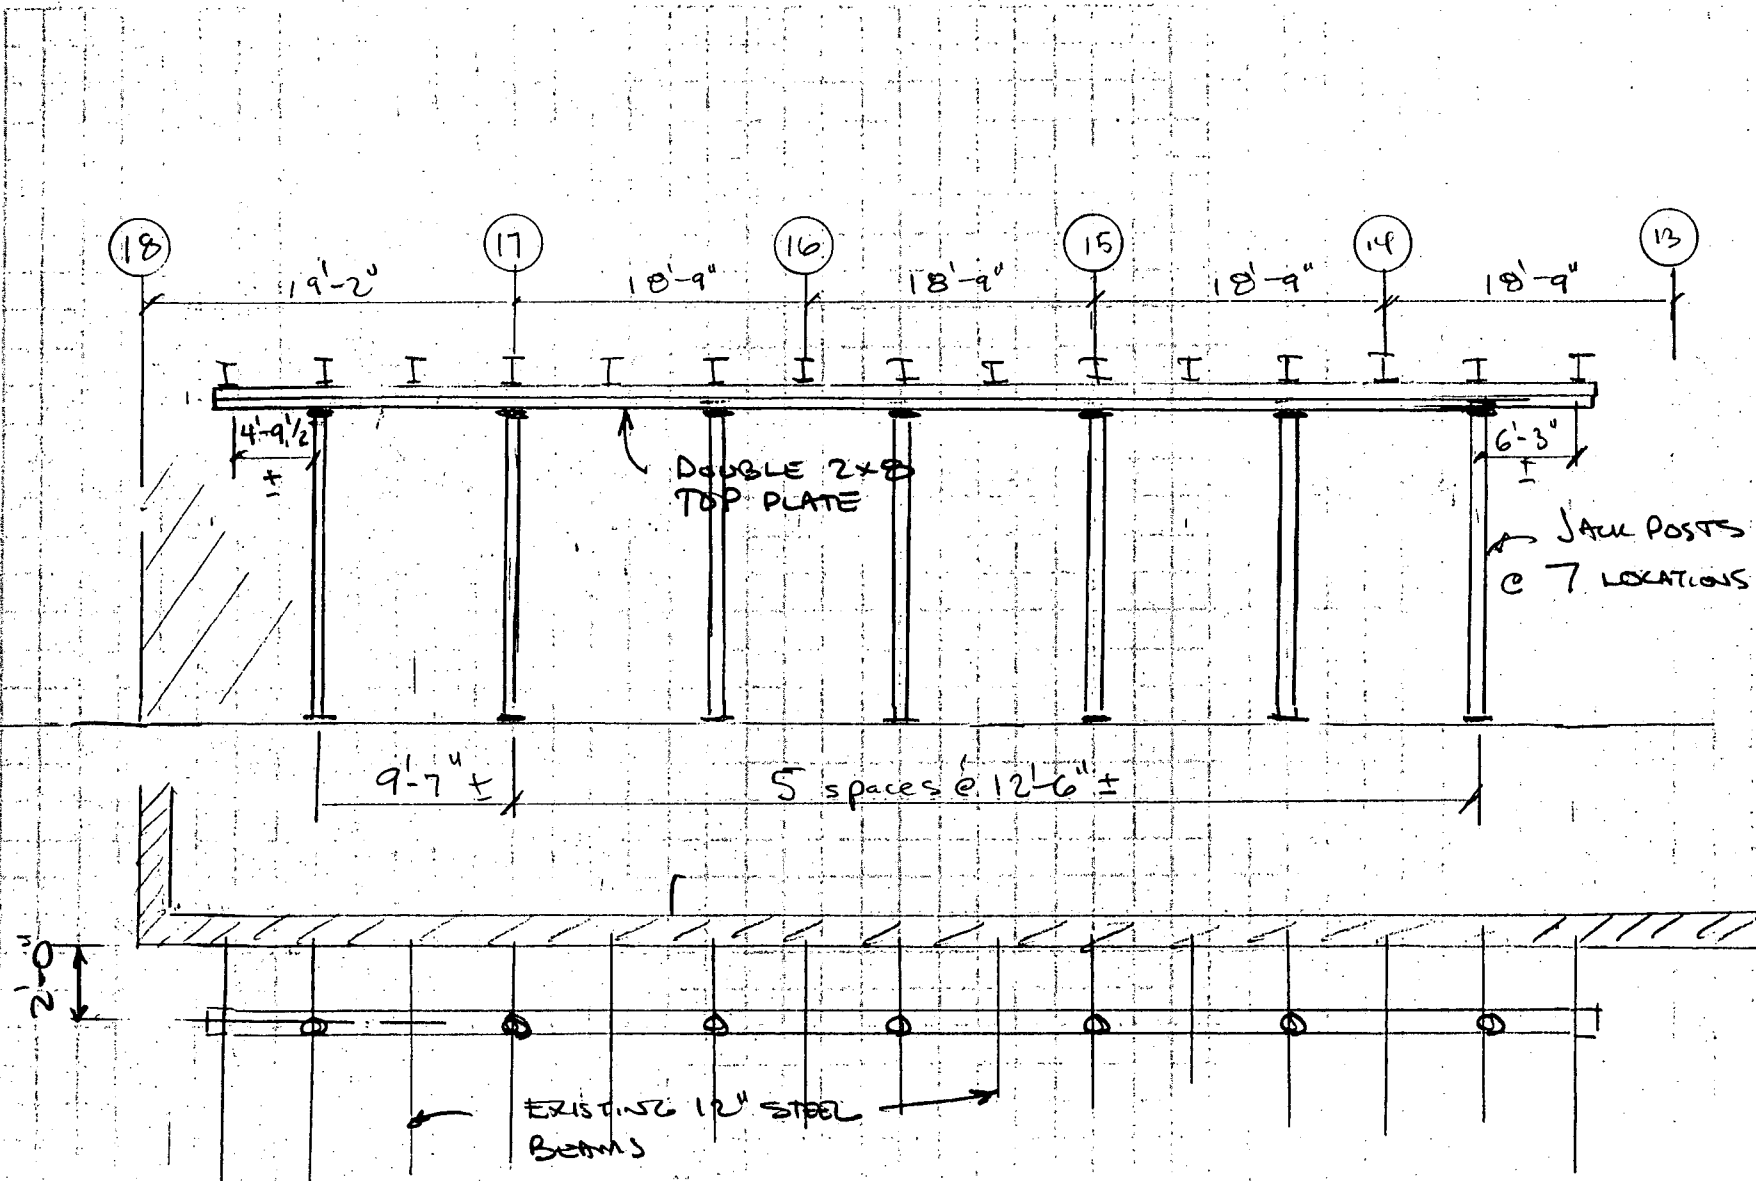
(18) DETAIL

| 18 | Beams are not adequately supported because brick wall is severely damaged. | Add jack posts and timbers to support underside of steel beams. See Detail <u>18</u> . |

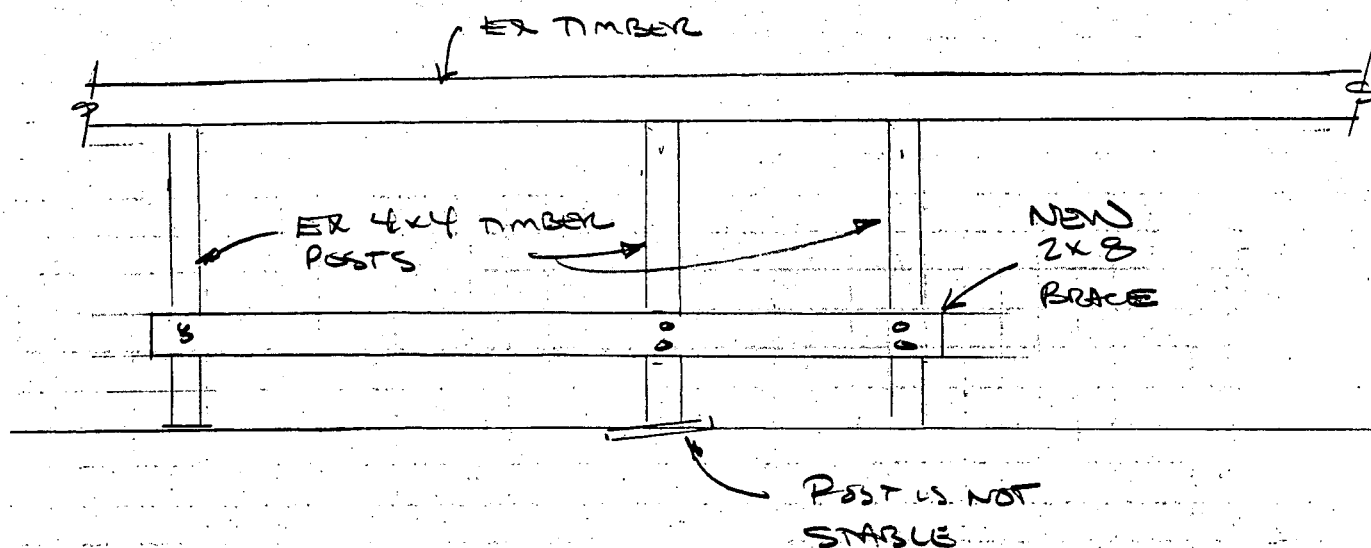
| 19 | Timber frame not adequately braced. | Add brace per Detail <u>19</u> . |
